The group of Orthodox churches, so well defined in Hateg Country and Hunedoara Region, is now completed by a less known monument, considered lost for a long period of time, the "Sfântul Nicolae" stone church from Bârsău.

Bârsău Village belongs to Tarău Commune and is positioned at about 8 kilometers North of Deva, on the road towards the Certej mining area. Placed on a hill slope, the stone church of Bârsău overlooks the village neighborhoods with its gracious silhouette (Fig. 1).

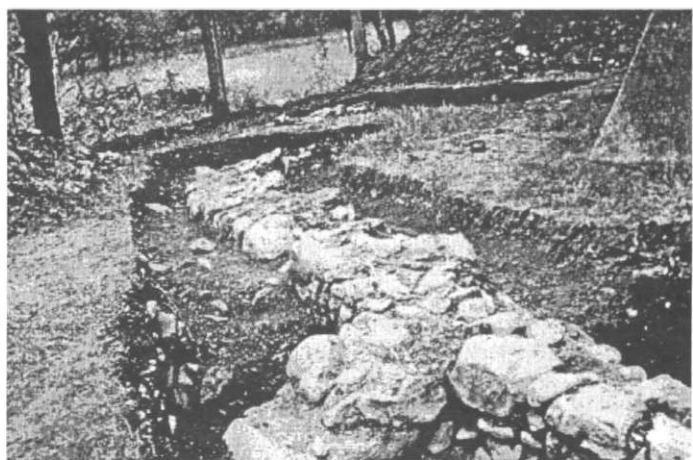
3 – Zidul de incintă cu contraforturi de pe latura de Nord.  
Enclosure wall with buttresses – northern side.

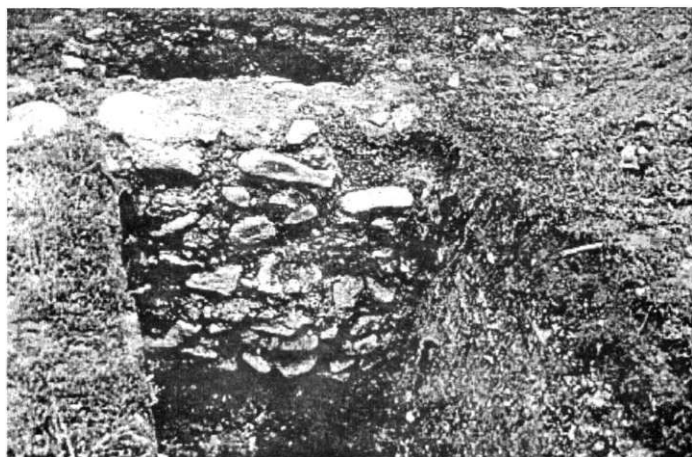
4 – Zid incintă latura Nord din secțiunea S12.  
Enclosure wall – northern side – section S12.

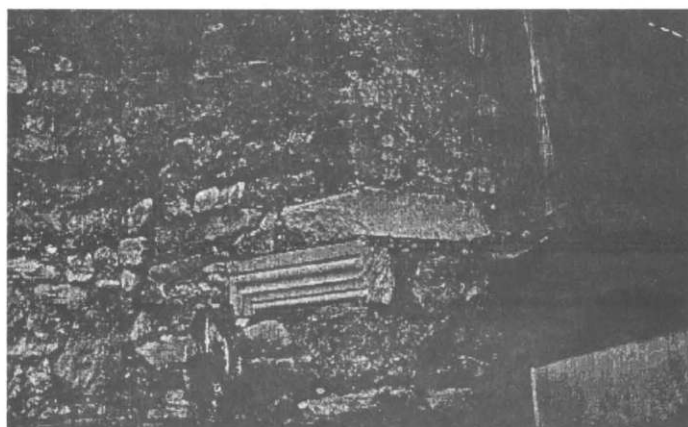
8,9 – Fragmente din piatră profilată  
din decorația bisericii încestrată în turnul clopotniță actual.  
Fragments of carved stone,  
from the church's decoration, reused in the present belfry.

The disaffecting of the crypts was made in the XVIII-th Century, when the wall meant to separate the interior into naos and narthex was built; the southern door was closed and the verandah that was also externally added to this side would afterwards function separately. At that time the buttresses from the northern and southern sides of the nave, as well as from the southwestern corner of the steeple were also added. The last important moment of intervention took part between 1877 and 1881, when the western tower collapsed (the extremely pronounced fissure was archaeologically noticed as continuing till the foundation basis). At that time the church was enlarged by about 1 meter towards the West, and a new steeple was built. The steeple's western wing was positioned on the old enclosure wall, disaffected at that time. In the interior, the separation wall was abandoned by the building of a trellis - work mast, and the church will be elevated with about 1 meter (Fig. 8-9).
