A TEUTONIC STRONGHOLD IN THE CARPATHIAN MOUNTAINS

EUGEN S. TEODOR, ANDRÁS SÓFALVI,
DAN ȘTEFAN, RĂZVAN BOLBA

KEY-WORDS: LIDAR, hillfort, palisade, C14, Teutonic Order

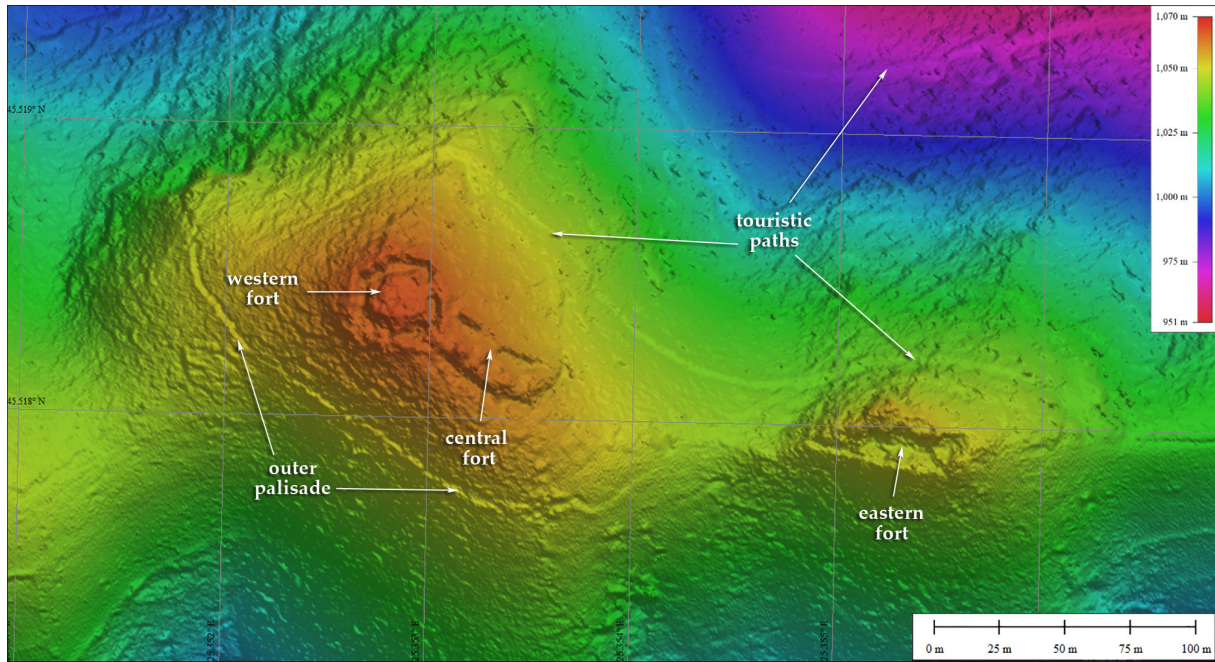
Fig. 4. The strongholds near Măguricea Branului. LiDAR data, HSV shader; with the main benchmarks.

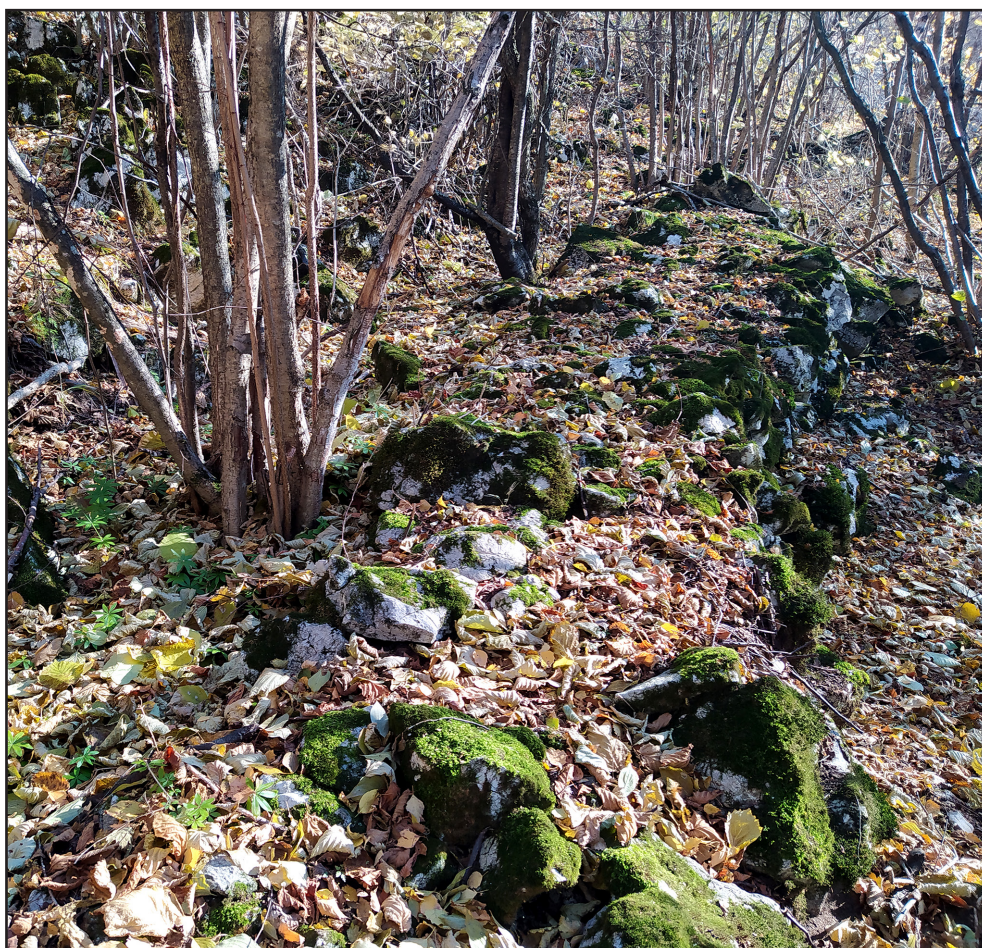
Fig. 6. The dry wall southwest of the eastern stronghold, view towards east.

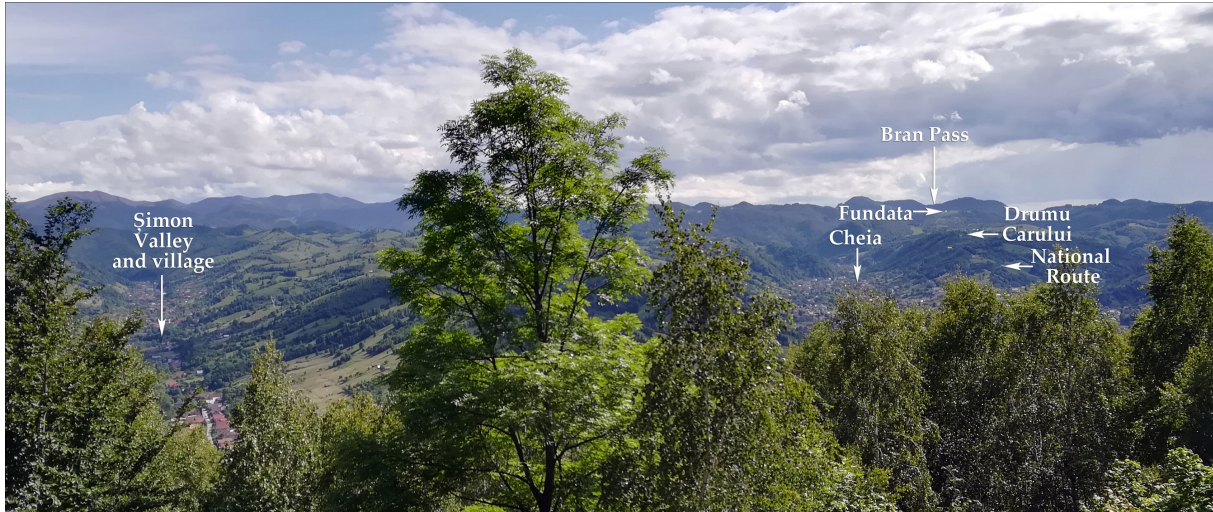
Fig. 10. Photograph taken from the eastern stronghold, view towards south.

– but also the time to do it, as their border guards stood there for many decades. As for the reason for which that modern post has been built on the ridge, it is the same as for any military climbing of the mountain here: the view is excellent towards the south, keeping in sight the Bran Pass (Fig. 10).

- Fig. 10. Fotografie luată de pe cetatea estică, vedere spre sud.
- Fig. 11. Săpăturile arheologice de pe fortificația estică. Fișier LiDAR, rezoluție 0,5 m, evidențierea pantelor („slope shader”).

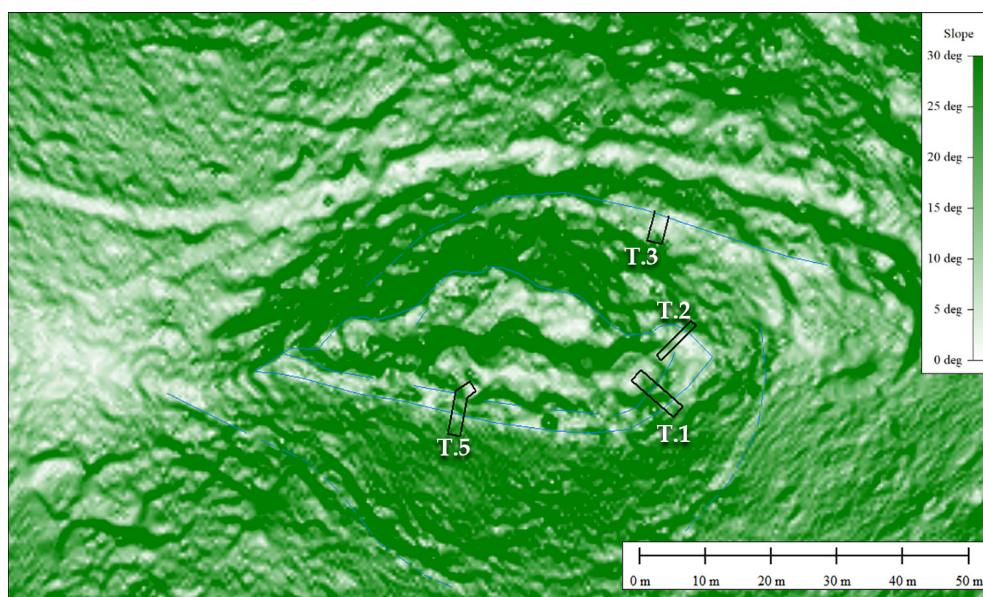
Fig. 11. Archaeological trenches on the eastern fort. LiDAR file, 0.5 m resolution, slope shader.

Our last trench on the eastern stronghold has been made against the large palisade located northeast of the main fortress, being referred to as Trench 3 (see again the Fig. 11 for location). It was supposed to check the massive

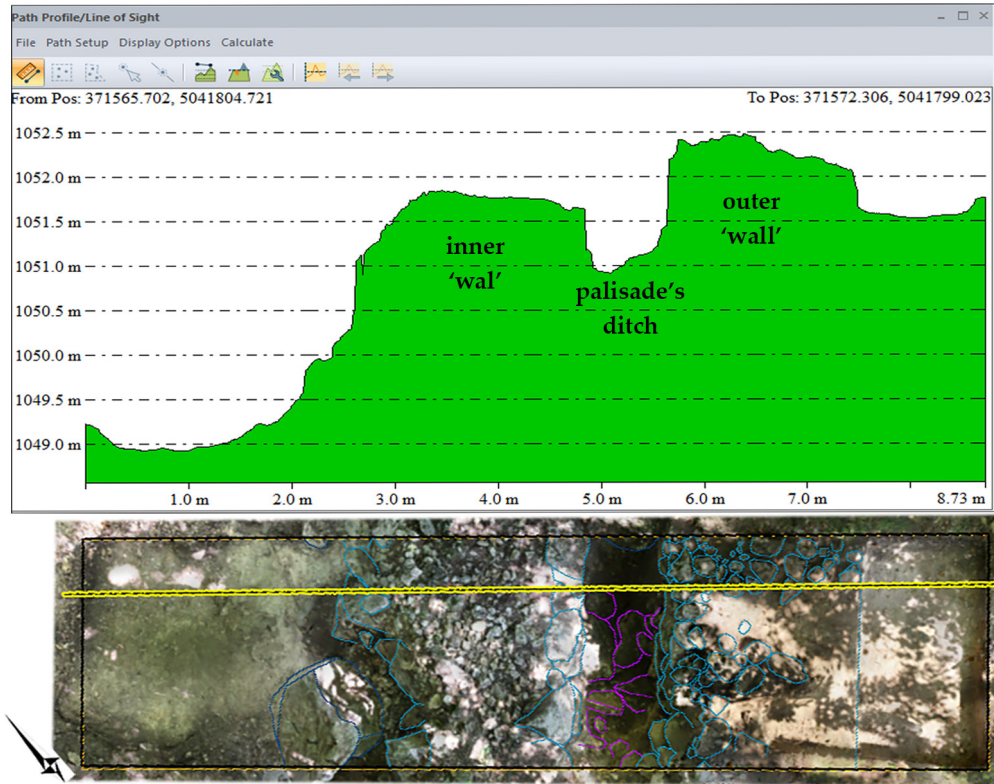
Fig. 12. Trench 1, orthophotograph (resolution 0.5 mm) and section over pendant terrain-model (res. 2 cm), projection UTM 34.

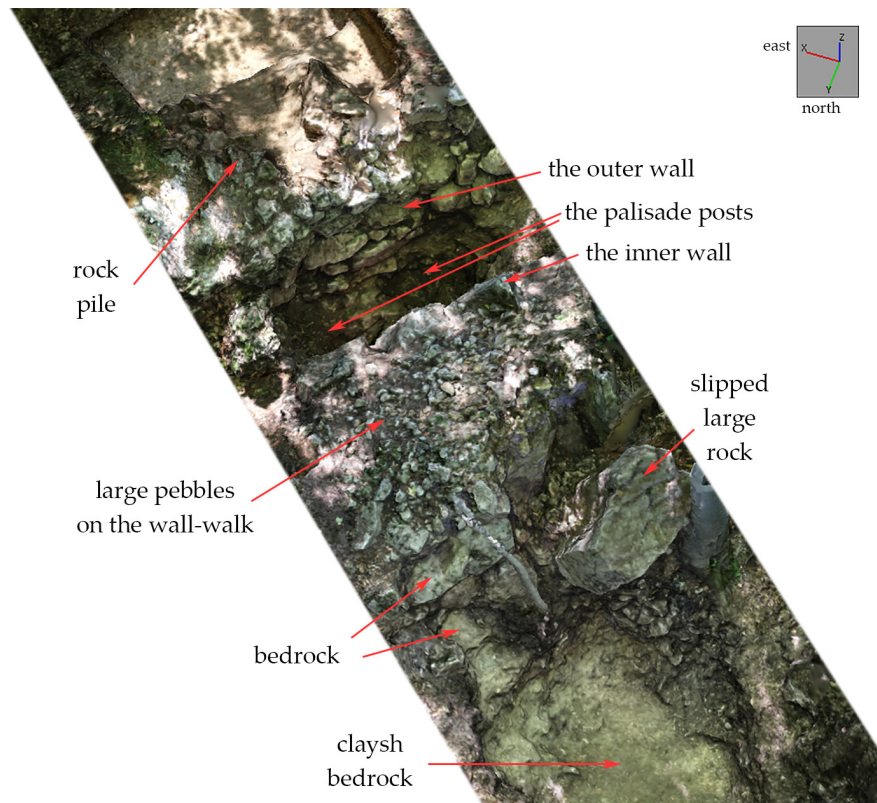
Fig. 13. Trench 1, orthophotograph (res. 0.5 mm), ortho mode, view in perspective, describing the main parts of the defences.

The outer wall is a proper wall (although a dry one) only where it faces the groove (Fig. 13); six (irregular) rows of the elevation are conserved here, made almost vertical, on a height of one metre. Immediately to the southeast (towards the exterior) we found only what could be described as a ‘pile of rocks’, preserved (or made) uneven, stretching for 1.8 m towards the valley, at its widest, but completely missing nearby. We did not find a good explanation for a while, but the subsequent comparison with other sections (as the Trench 5) was fruitful. The issue will be addressed later on.

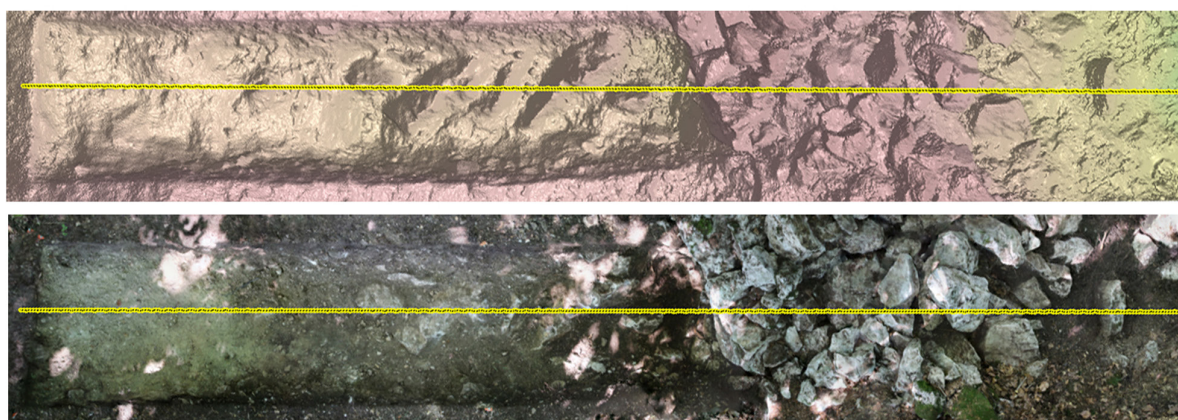
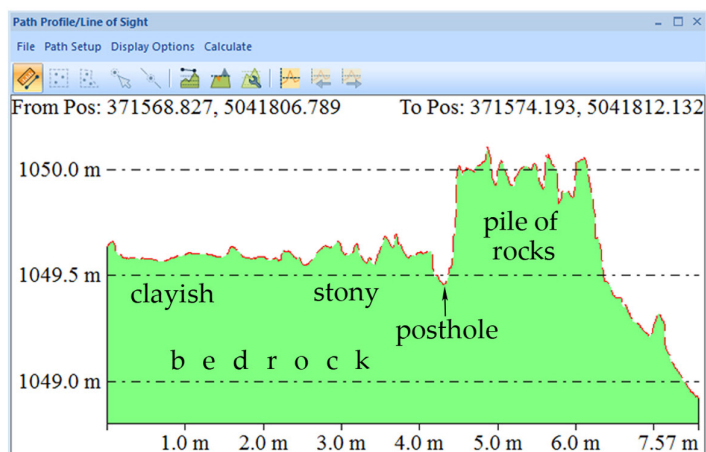
Măguricea Branului, trench 2.

- terrain-model (res. 3 mm)
- orthophotography (res. 0.8 mm)
- altimetric section

Fig. 15. Trench 2, terrain-model (res. 3 mm), orthophoto (res. 0.8 mm) and altimetric section, UTM 34.

The second trench (T.2) has been made against the eastern precinct, where a pile of rocks was clearly visible, but no inner wall or ditch were in sight. It is 7.35 m in length, oriented towards the northeast, and has only 1.1 m in width, as a deep dig was not expected. It was shallow indeed, the bedrock being found immediately below the grass (Fig. 15). Interesting to note, it is clayish at the south-western side³⁰, but made out of rocks, in their natural orientation, in the middle area. This time, the pile of rocks is not suggesting a wall at all, although its inner edge is vertical, has a width of 1.85 m (similar with the situation on T.1), with some of the pieces being rolled on the north-eastern slope. At its inner limit, nevertheless, a pit was found, dug in the rocky layer, in order to accommodate a post of the palisade, with a diameter of about 0.7 m, no deeper than 10 cm. As the trench is so narrow, we cannot be very confident, but apparently the continuous ditch of a palisade is not present. Northwest of the Trench 2, or just a few metres away, there are no signs of an artificial barrier, as the natural rock is profiling into the landscape.

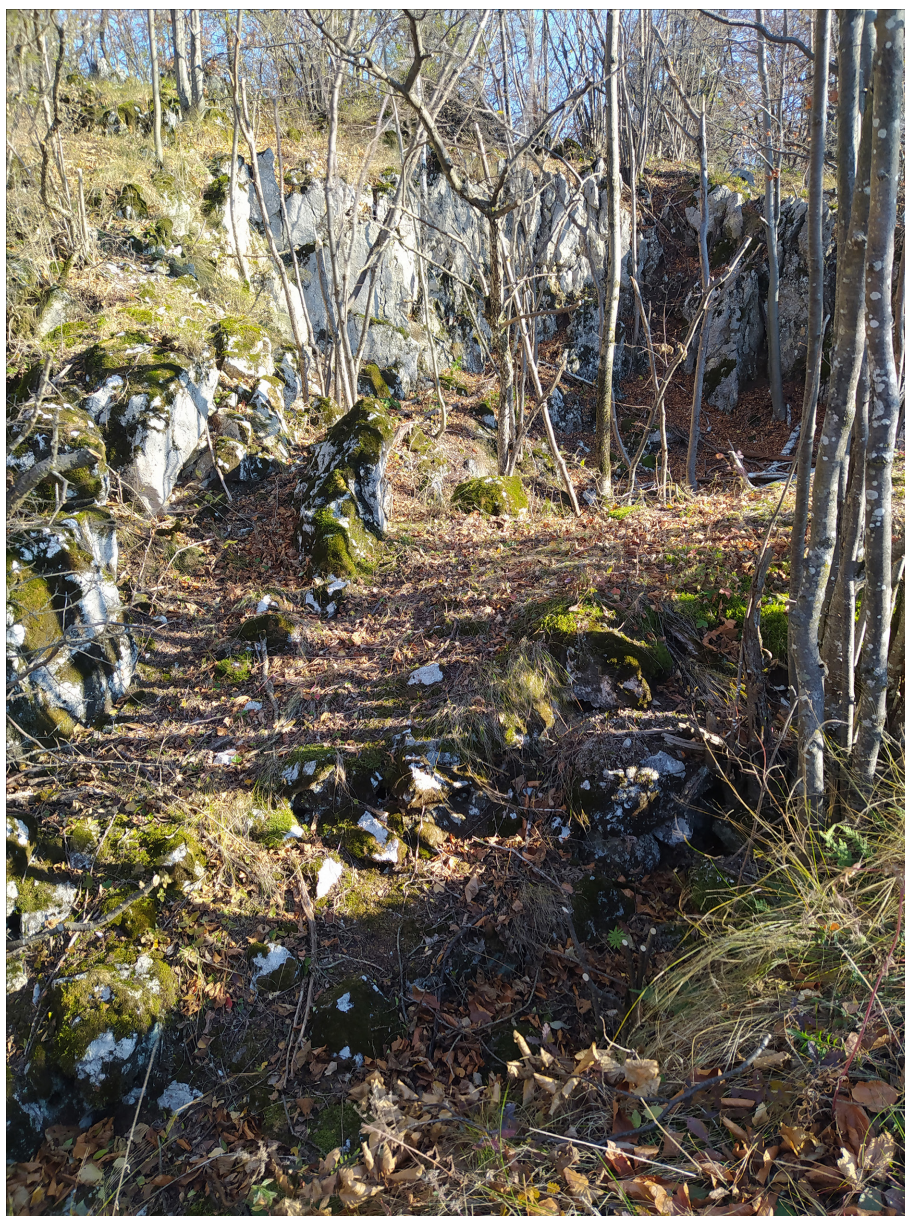
Fig. 17. Photograph taken on the eastern stronghold, towards the 3rd 'room' of the quarry, in late October 2021, from southwest. In the foreground – the groove between the outer and the inner walls.

pictures, but also made it difficult to acquire accurate RTK GPS data³¹. Each of the three larger rooms³² have been processed separately, then the dense cloud points of points was imported into the GIS application, where the tree trunks were cut off, then the dense cloud was been turned into a DEM, as rendered in Figure 16. The new DEM (originated in the dense cloud point) is far more detailed than our LiDAR data, having a resolution at 1.1 cm per pixel. There are obvious differences between the LiDAR file at 0.5 m and the new DEM at 0.01 m. The main gain was a better understanding of the space inside the former quarry. We noticed the clear-cut separation between 'rooms' 2 and 3, where the original shape of the land has been maintained for the northern and central area of the quarry, very likely with a purpose (Fig. 17). What would that be?

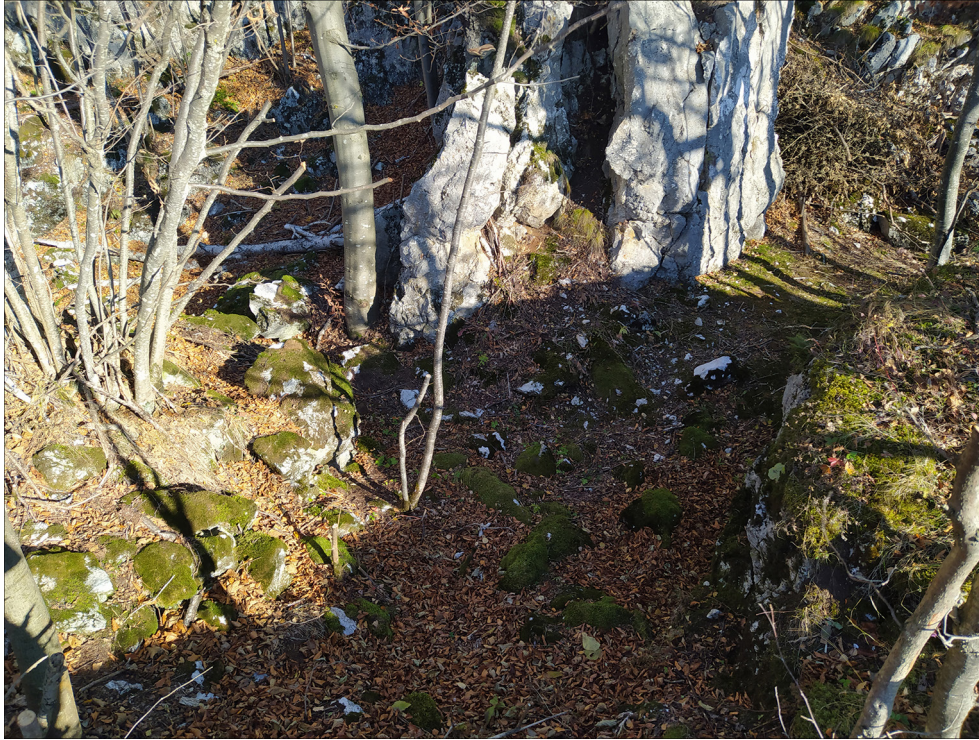
Fig. 18.
Photograph taken on the eastern stronghold, in 30 October 2021, heading north. In the foreground – the interruption of the inner wall, very likely a gate; in the background – the cliff separating the 'room' 2 (at the right) and 3 (at the left). This is the place where later was done the Trench 5.

between these spaces (2 and 3 on Fig. 16) is standing exactly where, apparently, towards the southern precinct there is a gate, a place where the groove is absent and the inner 'wall' is missing (Fig. 18). In that place we have placed Trench 5, during our second campaign (2022), measuring (at the beginning) 6.6 x 1.95 m. The trench is made perpendicular to the precinct, leaving undug a strip of grass, in order to protect the precinct line (Fig. 19)³³.

³⁹ There was no other choice. We were digging in a hole (see again Fig. 18) and all the matter extracted had to be put aside somewhere; the only places where such a thing could be done were in sides, the narrow passing ways to the neighbouring 'rooms', the second at the east and the third at west. As the western exit was already locked by disrupted stones, an extended excavation was possible only towards the east.

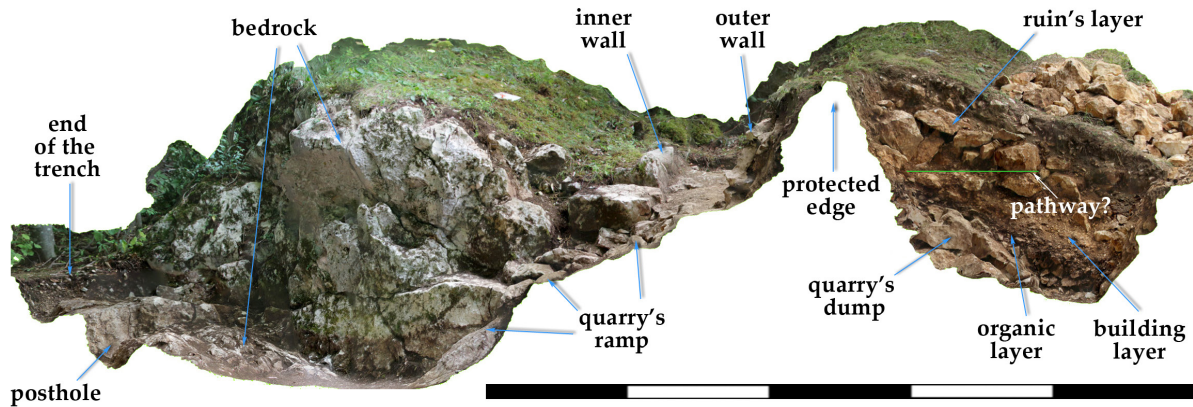
Fig. 20. Orthophoto of the eastern section of the Trench 5. Note that outside the trench has been cleaned a stretch of the palisade's ditch.

the ground³⁴. The layer is clear, of a neutral colour, with loose connections between the stones, as they were just dumped, not walled. Above it occurs a blackish, organic layer, relatively thin, about 10 cm, which should be due to the abandonment of the site for at least one generation (more likely two or three), time needed for the vegetation to thrive³⁵. Above it begins another layer containing rocks, but reddish, not very frequent on the site³⁶. The lower part of the layer is made mostly of pebbles and reddish soil³⁷. At the top comes a layer of flat stones, suggesting a pavement running outside the wall, overlaid by the ruined upper wall; we then have to admit that the wall was at least half a metre taller than today (Fig. 20)³⁸.

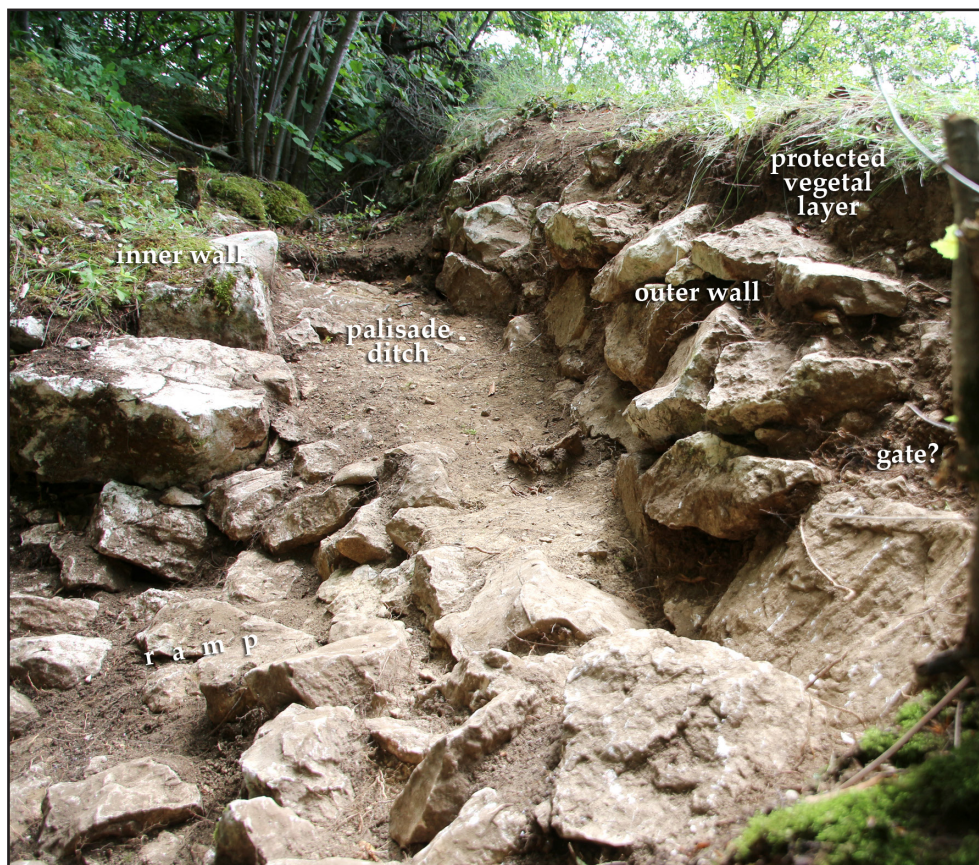
Fig. 21. Photo taken in the Trench 5, heading east, along the entrance and the palisade ditch.

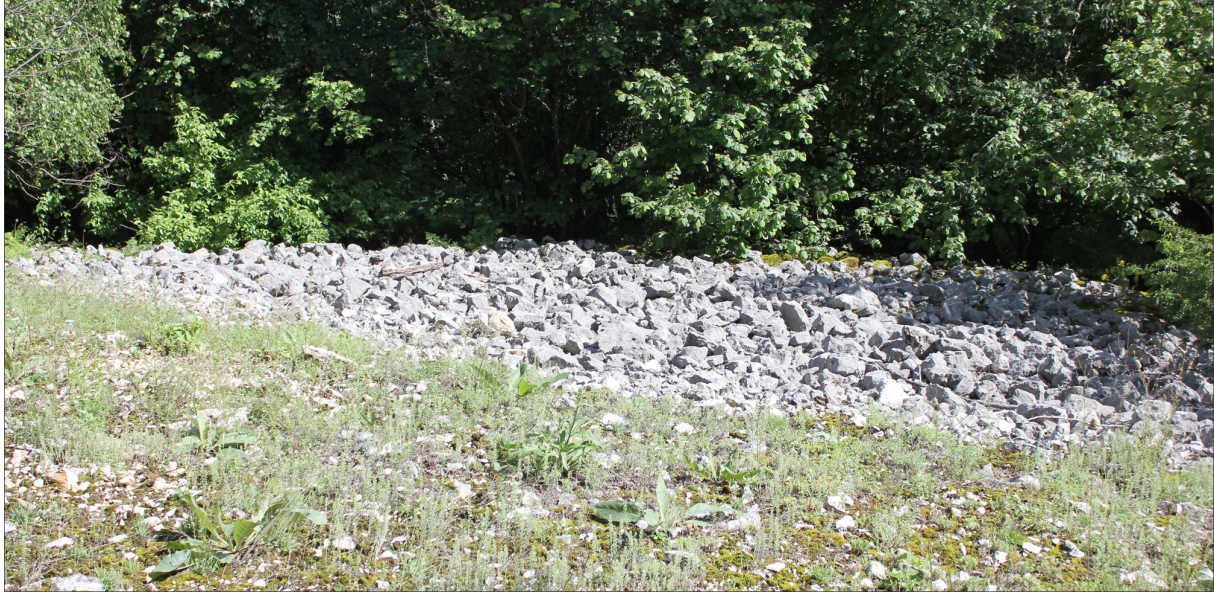
Fig. 23. The southern slope and clearance near the eastern stronghold, gathering stones rolled from the fortification. The slope has an average tilt of 29° (or 55.4%).

³⁸ Such a hypothesis is strongly supported by the rocks rolled on the slope and gathered south of the stronghold (see below, Fig. 23).

Note that the inscriptions NEOD? And IUXI are not pairing themselves as for the type of chiselling. In the first case a tool with a flat tip was used; in the second case, a pointed tip, very narrow (as a nail), is more probable. They are old anyway, both of them. The clue in understanding that is the colour of the rock. Fresh extracted limestone (or a fresh scratch) is whitish (as in Fig. 21), even bright in a strong light; the limestones long time exposed in the air turns grey, as one can see in Figure 23. Looking now back on Fig. 22, one can see that our cliff is grey, as well

⁴¹ This second inscription (Fig. 23, IUXI 2) has been read, by one of us, as RUXI, which is laughable and suggesting that the inscription is close to our time. Comparing the two versions, one can see that in the first case (IUXI 1) the first letter is not R, but likely I).

as most of the lines making up the letters. Below IUXI (1) one can see also two smaller X, whitish, as the scratches are very likely much younger⁴².

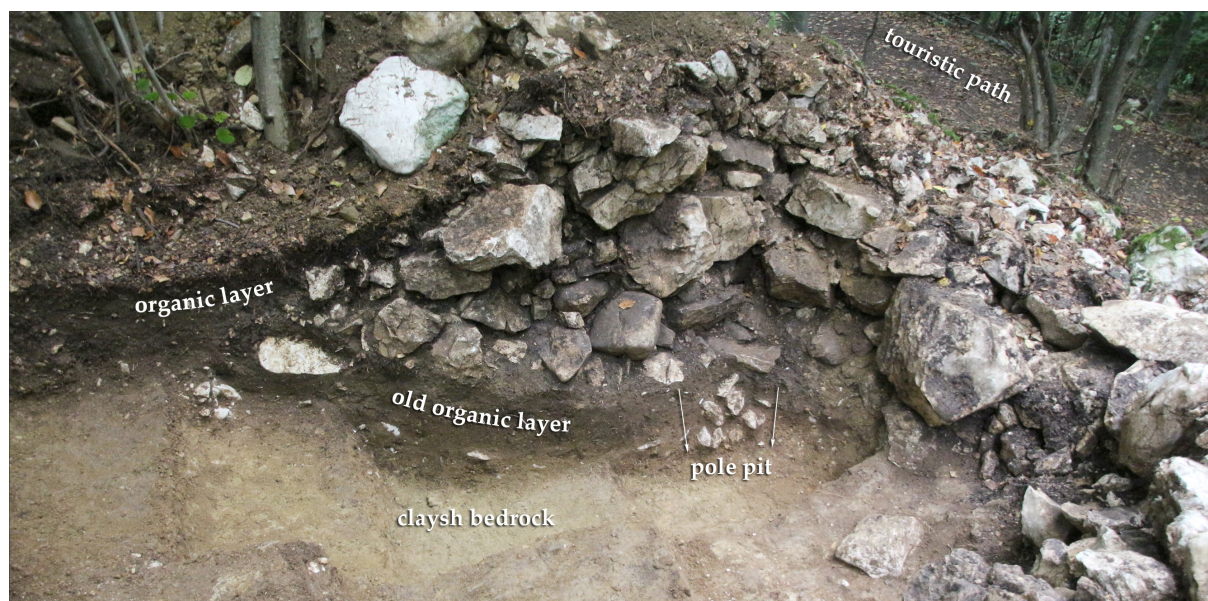
Fig. 25. Eastern stronghold, northern palisade, Trench 3, photo against the western section.

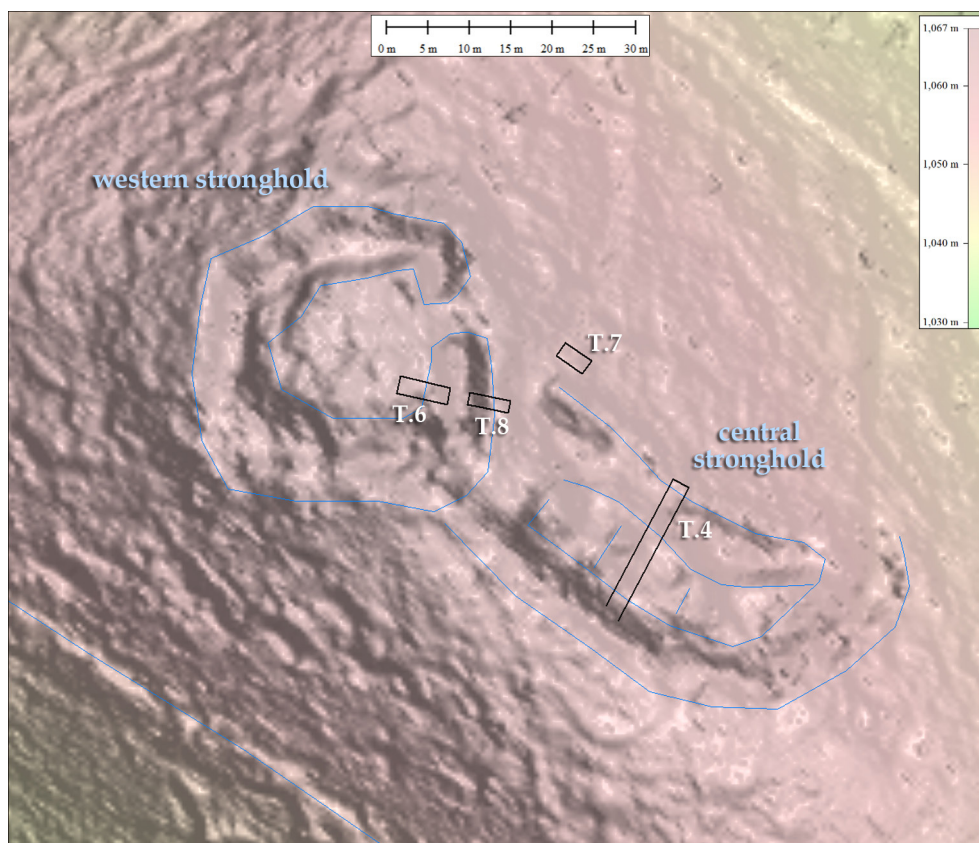
Fig. 26. Archaeological trenches on the central and western strongholds.

Trench 8 has been made a few days later, following the direction of the northern side of Trench 6, cutting through the tip of the outer defences of the western stronghold (see again Fig. 26 for location). The highest part of the circuit is made up of pebbles, a construction material usually employed to make an alley over a bumpy surface. As a consequence, we were expecting the line of the palisade to be about one metre east of the tip of the embankment (Figure 35, noted ‘?’). Digging the place, we have found huge stones along the northern section, one of them weighing at least two tons. A good place to fix a palisade pole would be here, between the large rocks, but no trace of wood has been found there. Traces of wood popped up one meter below. An unusual, triangular tip of a pole has been found near the northern section, kept in place by a board half buried into the antique soil (Figure 36), along the level line. Immediately below, towards east, a group of stones could have been part of a dry wall, not very well preserved. West of the palisade’s pole we also found marks of wood turned into tiny bits of charcoal, on a surface, suggesting a decayed decking.

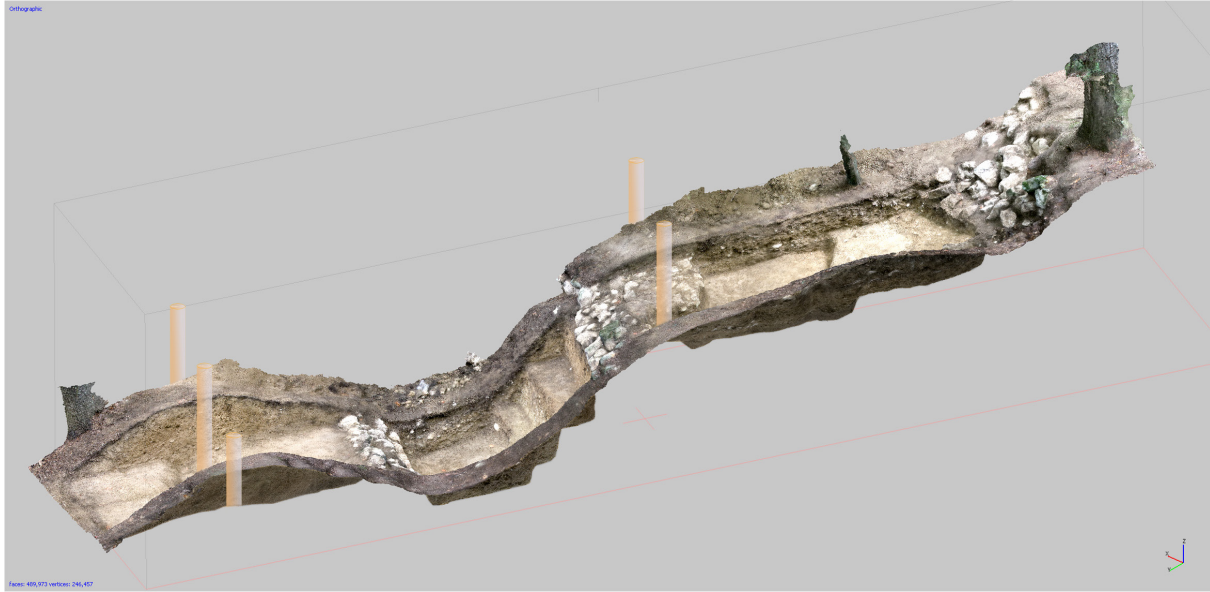
Fig. 28. Central stronghold, Trench 4, point cloud, orthographic mode, perspective view from northwest. Poles of the palisade added.

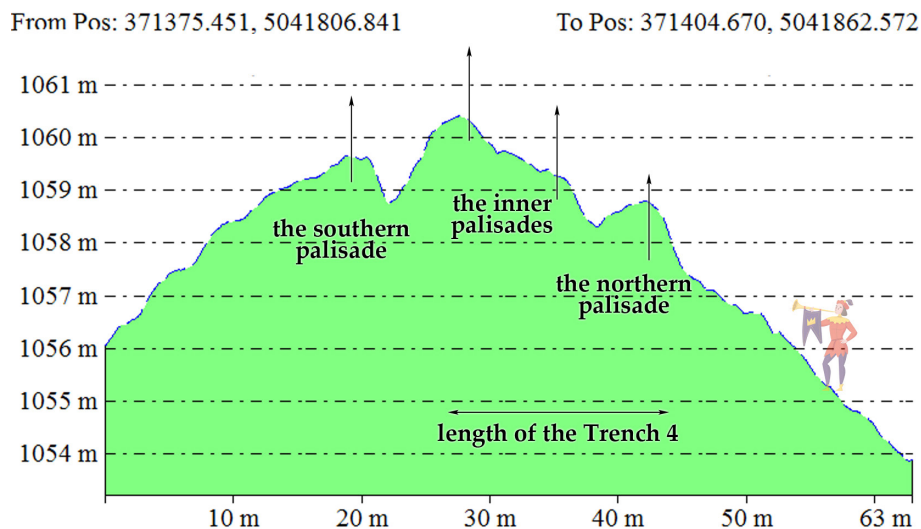
Fig. 29. Central stronghold, altimetric section along the Trench 4, LiDAR data, resolution 0.5 m. Projection UTM 34. Study of the visibility.

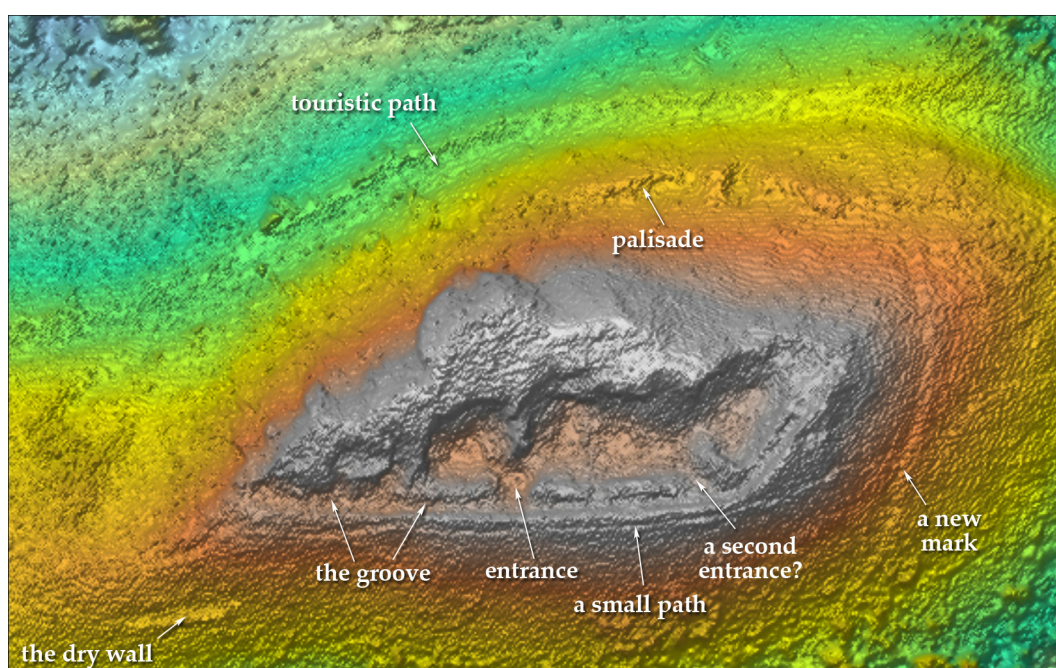
Fig. 30. The second LiDAR file, resolution 25 cm, on the eastern stronghold.

On the eastern stronghold there are not many news (Figure 30). The northern palisade stops at the middle of the defended cliff, but this was already known. The dry wall at southwest is located where we have seen it, but has a slightly different orientation. At the opposite side of the stronghold there is a new mark, possibly another palisade, closing the entire eastern slope⁵². Another interesting fact is the absence of the inner wall near the separation between rooms 1 and 2, a fact to be verified by future research. A situation completely new, never observed due to the dense bushes, is the absence of the inner wall at the western end, in front of room 4.

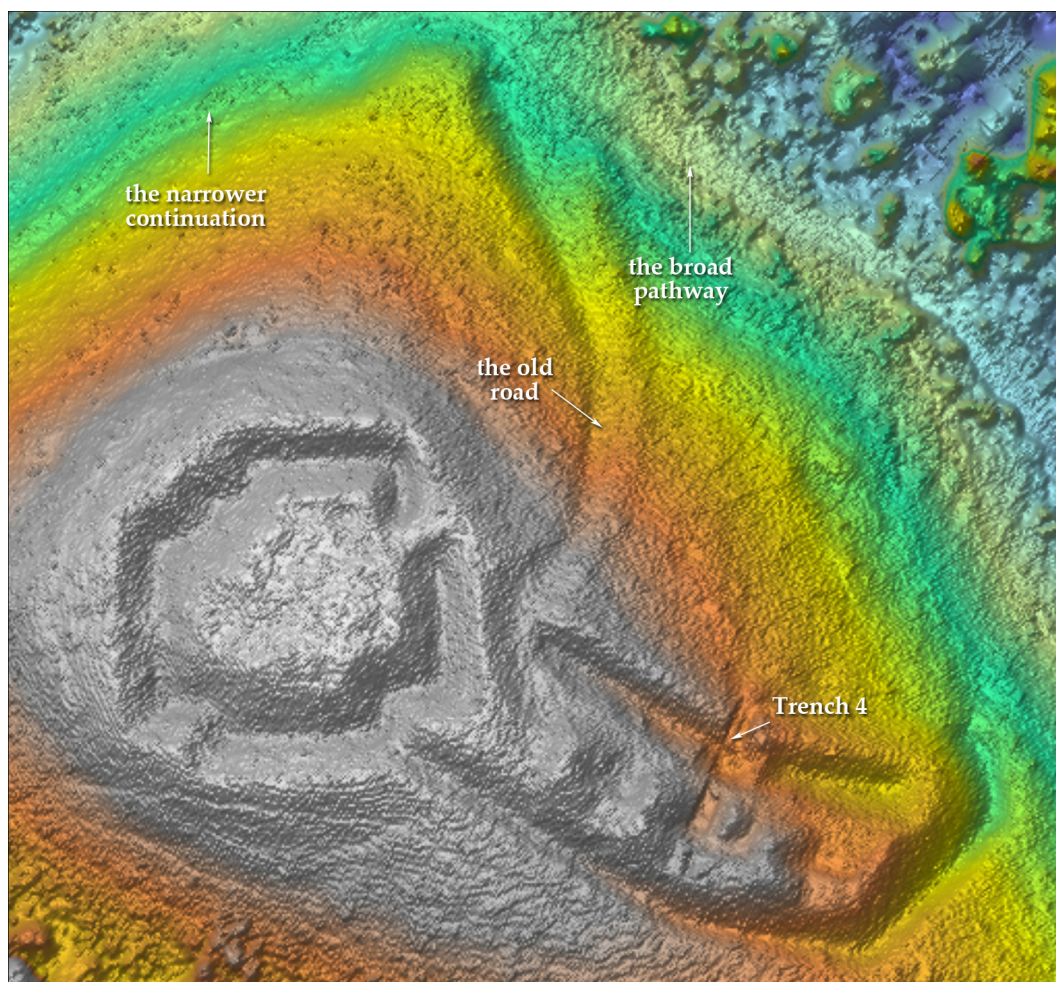
Fig. 31. The second LiDAR file, resolution 25 cm, on the western complex of fortifications.

If looking back on Fig. 31, one would see 'the old road', connecting the broad pathway and the gates to both central and western strongholds. As the road becomes so obvious in the second LiDAR file, we have paid more attention

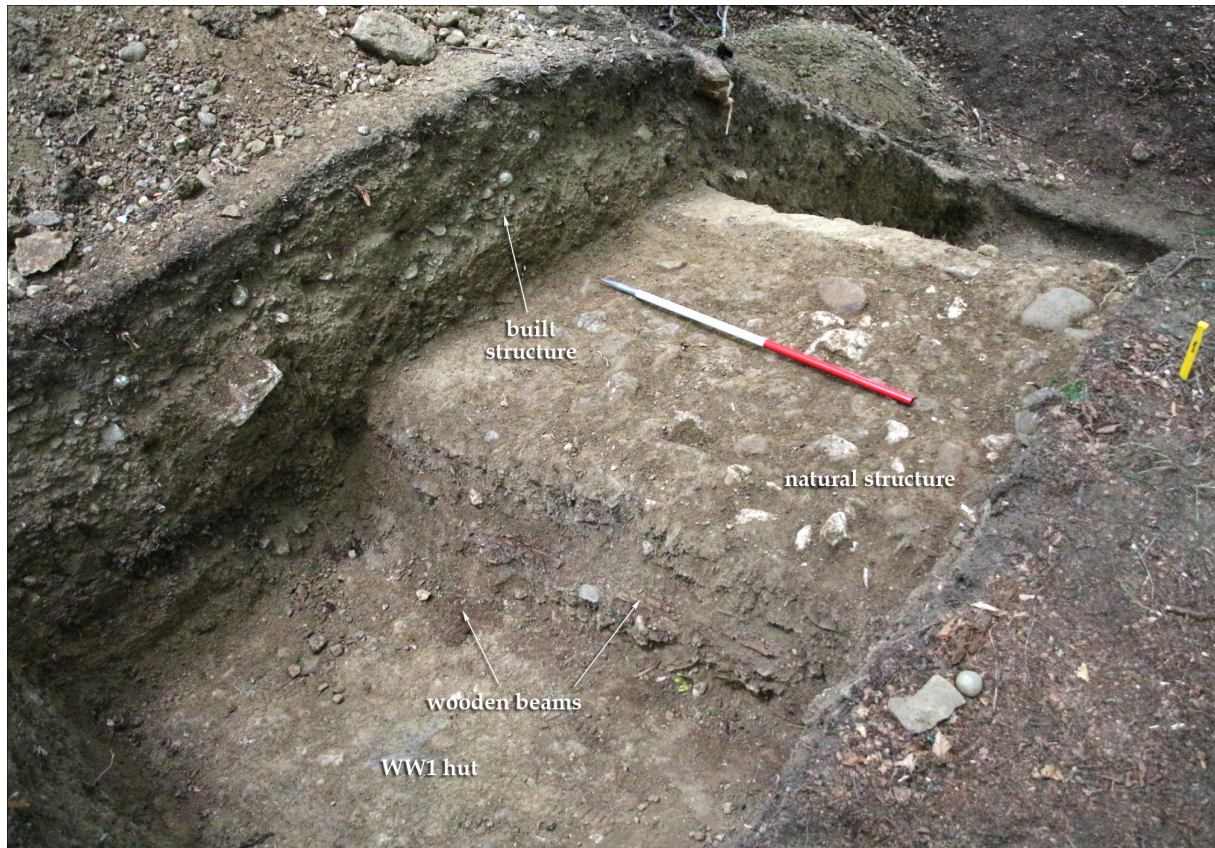
Fig. 32. Western stronghold, Trench 6, photo against the northern section. White-red stake at 1 m.

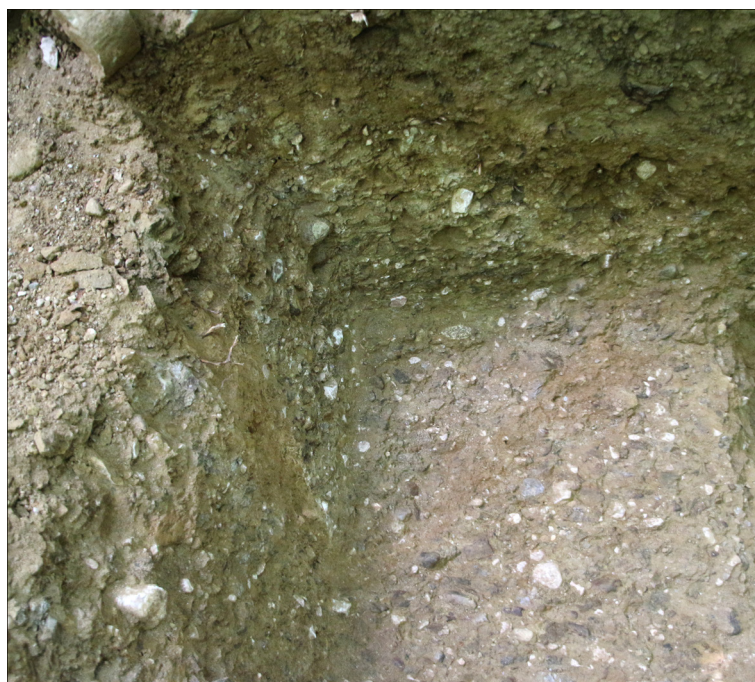
Fig. 34. Western stronghold, Trench 6, detail with the palisade pole marks on the ground, near the northern section.

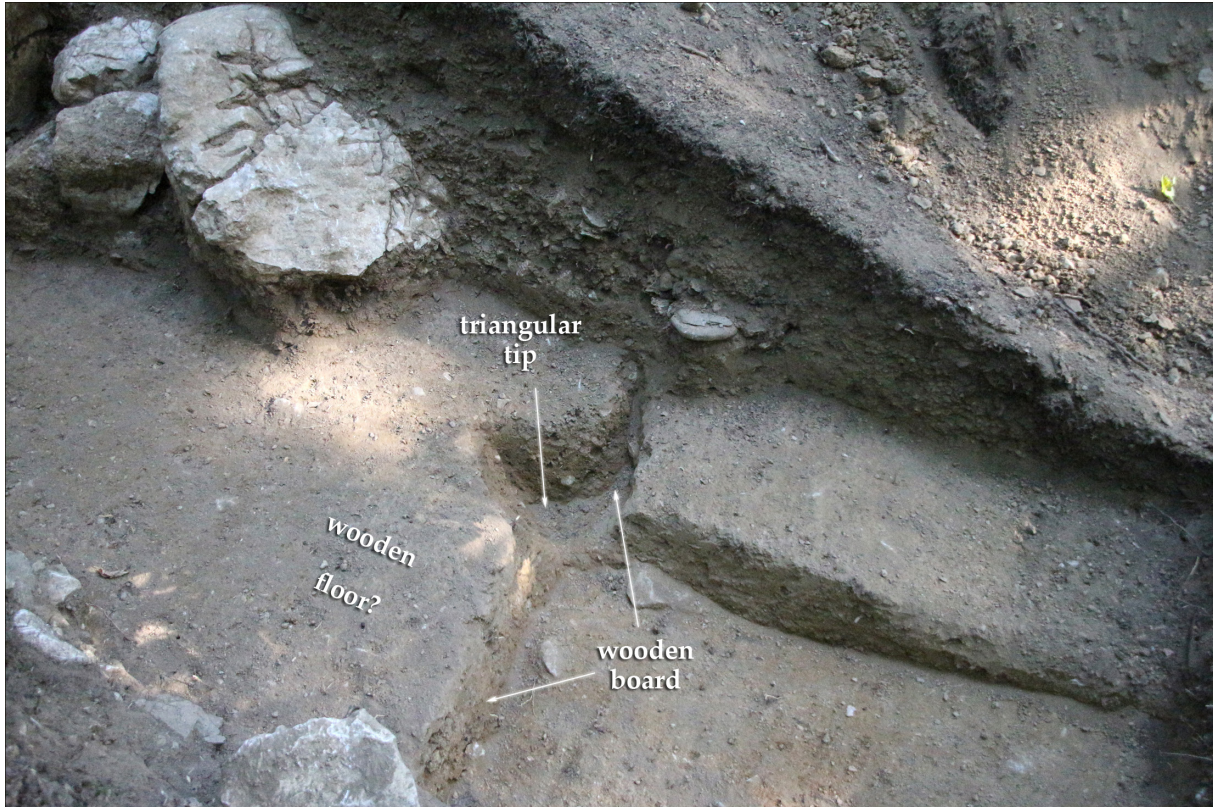
Fig. 36. Western stronghold, Trench 8, photo against the northern profile, detail from the lower part.

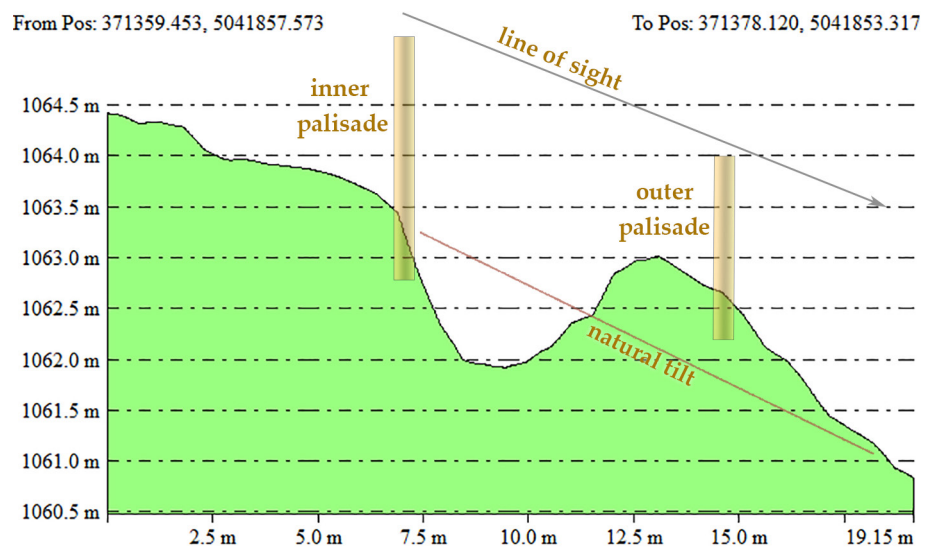
Fig. 37. Western stronghold, altimetric section of the terrain along the Trenches 6 and 8. LiDAR file, projection UTM 34. Study of visibility.

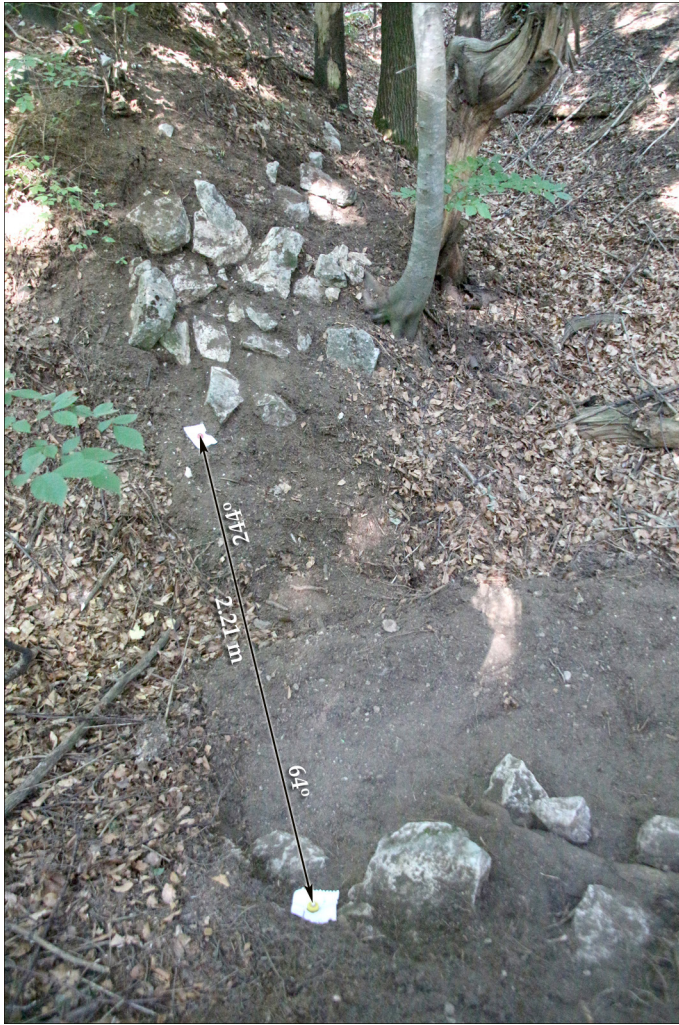
Fig. 38. Western stronghold, photo taken at the north-eastern corner, in the defensive ditch.

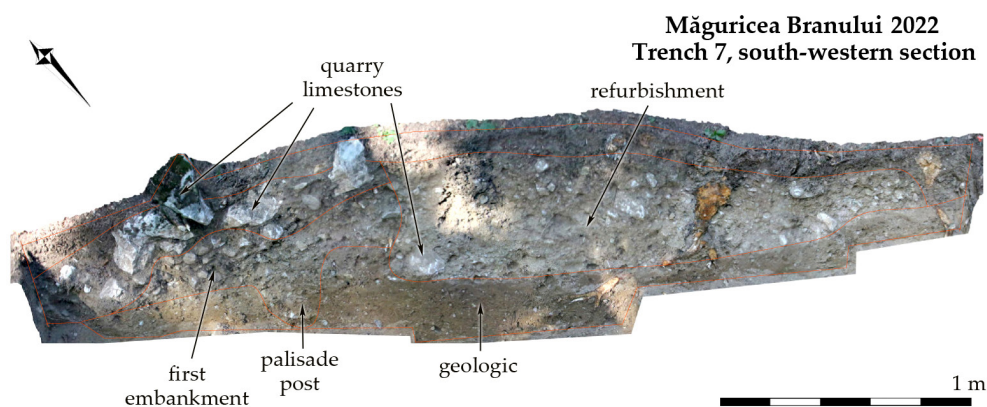
Fig. 39. Western fortification complex, the palisade near the gate. Trench 7, south-western profile, orthophoto.

The two parts of that trench are uneven, the interesting one being the south-western (upper) side. The geologic support is clayish, with small pebbles (Figure 39), similar to things seen in Trench 4, on the central stronghold. The embankment is small (about 0.4 m in height), but clear if looking at its stratigraphy. It obviously has two phases of construction: a palisade (with one posthole visible) and a small embankment added around (see the left-down side on Fig. 39); a second phase, which has brought several changes. The place behind the palisade (central and right part of the illustration) has been refurbished, dug below the level of the natural soil, and filled with a

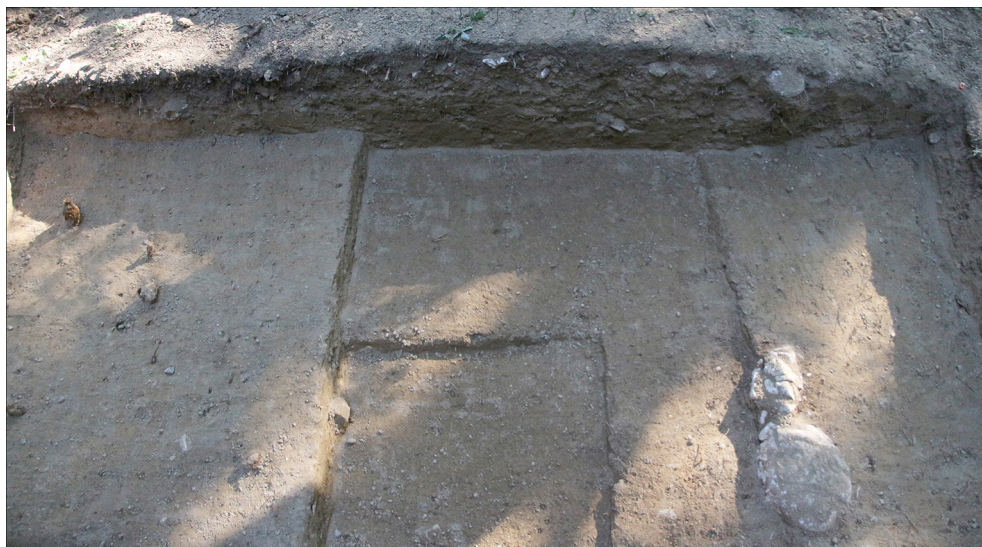
Fig. 40. Western fortification complex, the palisade near the gate. Trench 7, photo taken against the north-eastern profile.

As already said, the opposite side of the trench is very different: the embankment is almost absent (Figure 40); apparently, we found there an entrance. Looking at the shape of the land, the palisade was descending all the way down, about 65 m to the north, up to the intersection with the broad path. In that area, on the opposite side of the path (north of it) there is a group of large stones, possibly part of another small defensive construction (a tower?).
