A TEUTONIC STRONGHOLD IN THE CARPATHIAN MOUNTAINS

EUGEN S. TEODOR, ANDRÁS SÓFALVI,
DAN ȘTEFAN, RĂZVAN BOLBA

KEY-WORDS: LIDAR, hillfort, palisade, C14, Teutonic Order

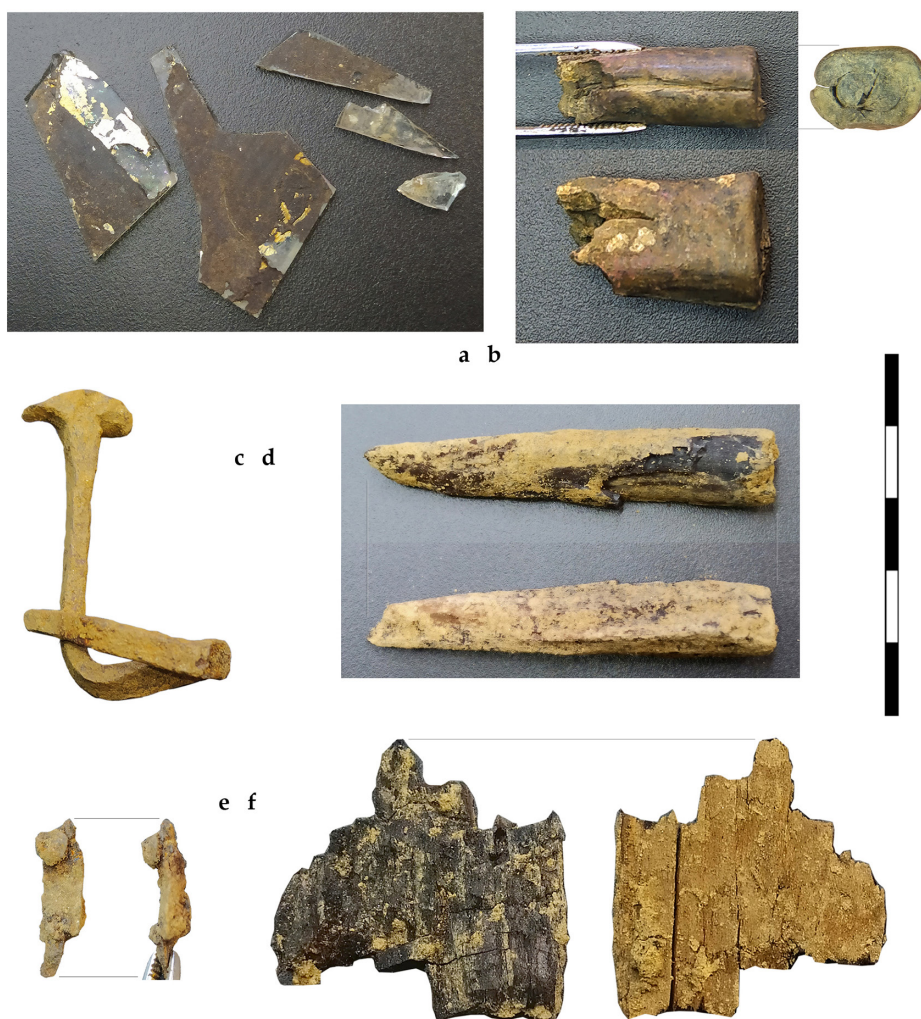
Fig. 41. Artefacts from digging: a) mirror shards, T.1, palisade's ditch; b) scrap metal, copper based alloy, T.1, northern side; c) iron nail from T.4, at the outer palisade; d) wooden nail, as c; e) unidentified iron device with a rivet, together with c); f) tree bark from T.4, the ditch of the palisade. All at the scale 1:1.

The only obvious artefacts associated with the construction activities were found in Trench 4, at the outer palisade or close. The ‘collection’ is made up of two nails (one of them is depicted in Figure 41/c; the other one is similar, but less preserved); a third nail, a small one, conserving only the head, has been found on the same trench, in the

The builders have obviously used wooden nails for completing their job, a deduction also supported by an actual find (Fig. 41/d), in the same area of T.4, between the dry wall 1 (as noted at the Fig. 27) and the outer palisade, where a wooden walk was made. The use of wooden nails is not that rare, both in vernacular architecture and in military architecture, including Roman fortifications in locations with difficult supply⁵⁹.

A small piece of iron, having a flat end and a rivet (Fig. 41/e), has been found in Trench 4, in the area where a wooden board was set, near the inner palisade. Another inventory item has been collected from the same area, a tree bark (Fig. 41/f), its function within the palisade setup being unclear.

The list of findings is completed by two artefacts lost after the strongholds were deserted. Mirror sherds popped up from the digging in Trench 1, found in the palisade ditch (Fig. 41/a). The type of mirror is a modern one, using flat transparent glass and metallic shifts on the back. It could be Venetian, but its earliest date is the 16th century⁶⁰. How could such a precious object reach the peak of the mountain, a couple centuries after the stronghold was deserted, is hard to say.

Another interesting – but puzzling – artefact is made of a copper alloy⁶¹, having a length of 27.7 mm (Figure 41/b), with a sheet wrapped around the core (both apparently made of the same sort of metal). The only thing which came to mind is a lock bolt, but it would have a circular section. The piece is broken at one end and cut at the other, and could be a scrap metal used for repairing bronze made objects; as scrap metal, it could be from any other place, and not necessarily from the fort. It was found at the north-western end of Trench 1, in the inner yard of the stronghold, and it could have any date, as no obvious context is present (other artefacts or a well-defined layer).

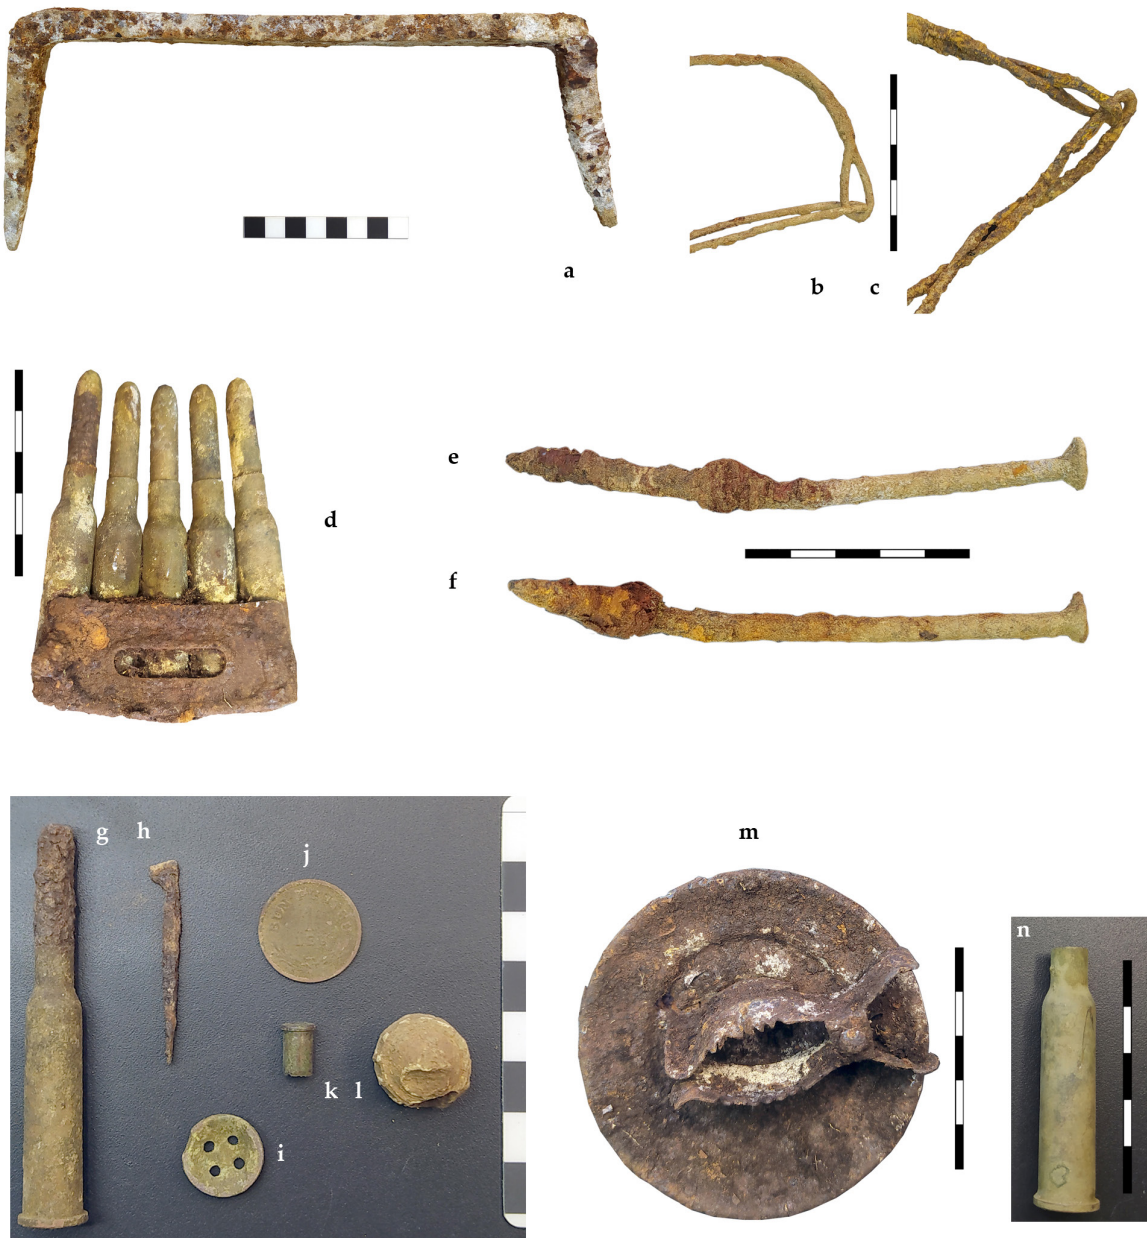
Fig. 42. Modern artefacts: a) construction clamp; b-c) twisted wire; d) en-bloc clip of cartridges for Mannlicher M93; e-f) industrial nails; g) unused cartridge for Mannlicher M93; h) handmade nail for splinters; i) shirt metal button; j) Romanian coin, 1924; k) small hunting cartridge; l) Brenneke hunting bullet (for wild boars, after WW2); m) candle support; n) used cartridge for Mannlicher M93.

Surprisingly, the most frequent type of object found is wire, of different diameters, mainly 1.6 and 2.4 mm. They are always twisted and hooked, two by two (as in the Fig. 42/b and c), and were found both in digging (especially

in the military hut from Trench 6) and outside, many in the middle platform of the western stronghold⁶³. They were probably used to keep the wooden boards together, for some improvised shelters, as suggested by the discovery of several pieces along a large clamp⁶⁴ (Fig. 42/a), about 5 metres west of Trench 6. The reason why the Romanian militaries used wires instead of construction nails is not clear; the nails are not absent on the site (see Fig. 42/e and f), but they are certainly far fewer; possibly a shortage of industrial nails⁶⁵. Speaking of nails, we also found a

small one, typically used for splinter roofs, handmade, with rectangular section (Fig. 42/h), but the evidence is too poor for inferring such a roof⁶⁶.

Another artefact possibly connected to the First World War is a candle support (Fig. 42/m).

Many of the artefacts are certainly related to civilian activities on the mountain, which is not a surprise given the small distances to villages located both northward and southward. Such would be a Romanian coin from 1924, with the value of 1 leu (Romanian coinage, Fig. 42/j), and several small change coins following the Second World War, mainly on the eastern stronghold⁶⁸. A small cartridge for hunting (Fig. 42/k), three broken axes, two different halves of oxen shoes, a large iron chain, most likely used to drag cut trees with oxen, and several other small discoveries such as a small anvil (?), or a few old beer caps (one made in Braşov, Czell brand) would fall into the same category.
